# Flexamat?

# Flexamat Standard

# Flexamat Plus

# Flexamat 10NW

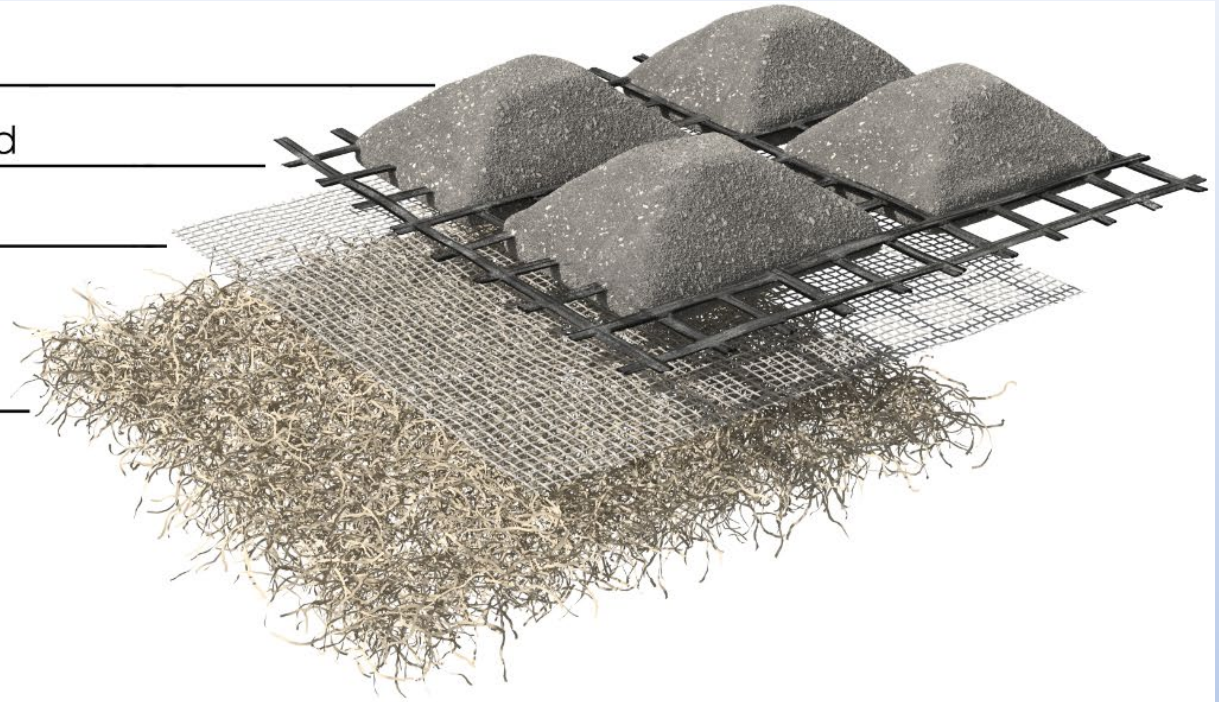
5000 PSI Concrete Blocks

High Strength Biaxial Geogrid

5-Pick Leno Weave

Curlex® II Wood Excelsior

- Above waterline
- Cohesive soil
- Full vegetation

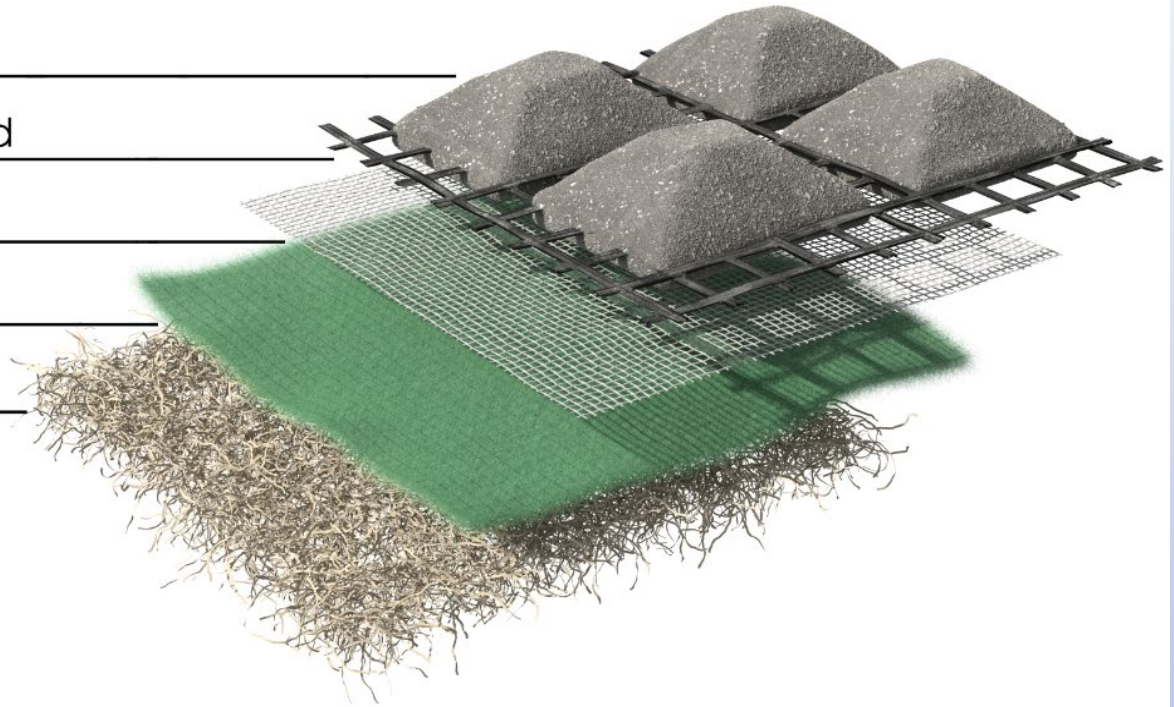
5000 PSI Concrete Blocks

High Strength Biaxial Geogrid

5-Pick Leno Weave

Recyclex® TRM

Curlex® II Wood Excelsior

- Within the water line
- Cohesive and Un-cohesive soil
- Transitional vegetation

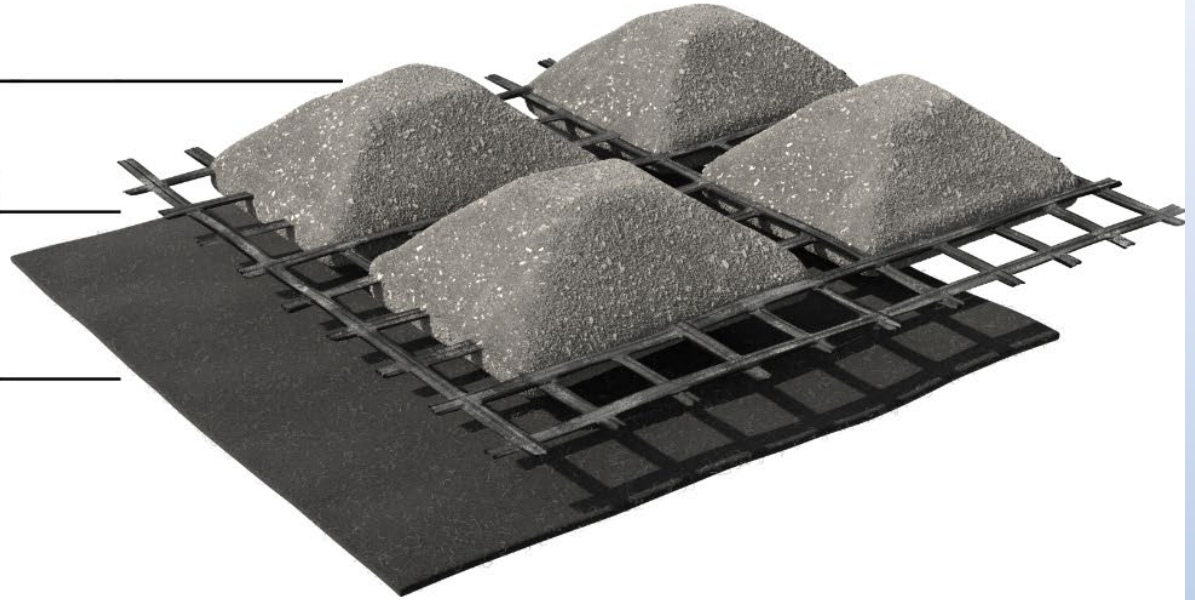
5000 PSI Concrete Blocks

High Strength Biaxial Geogrid

10oz. Non-woven Geotextile

- Below water line
- Cohesive and Un-cohesive soil
- No vegetation

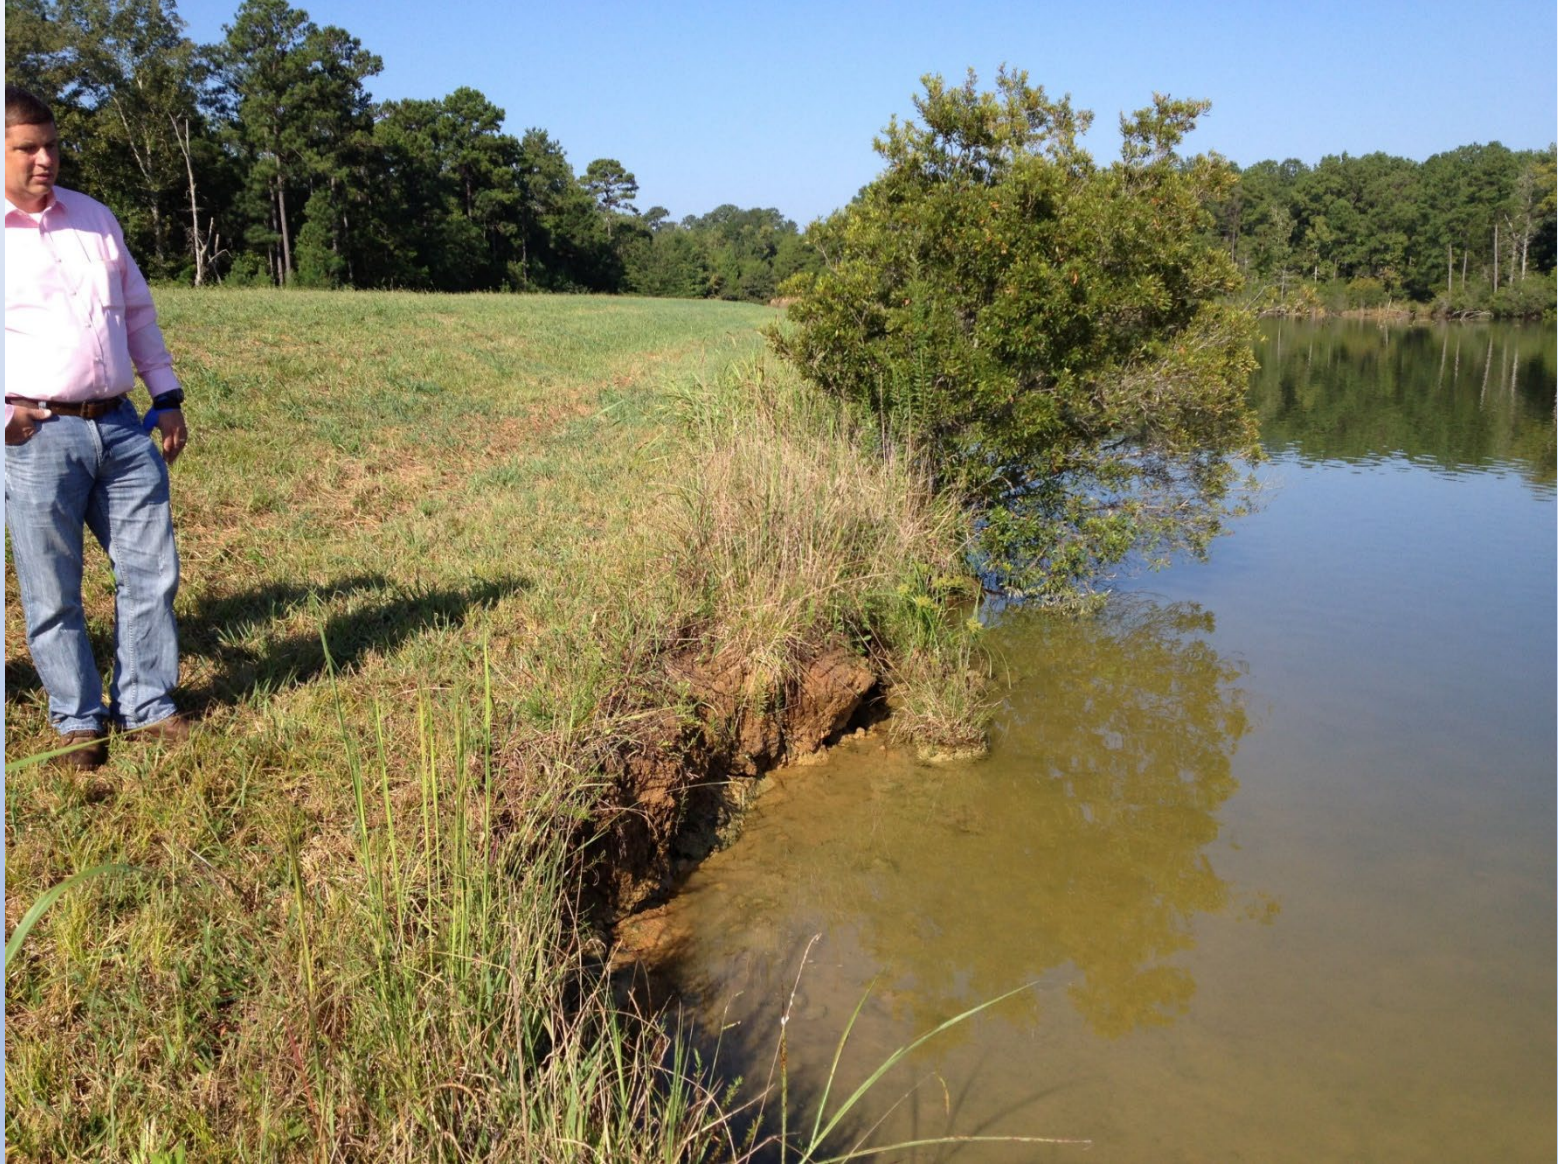
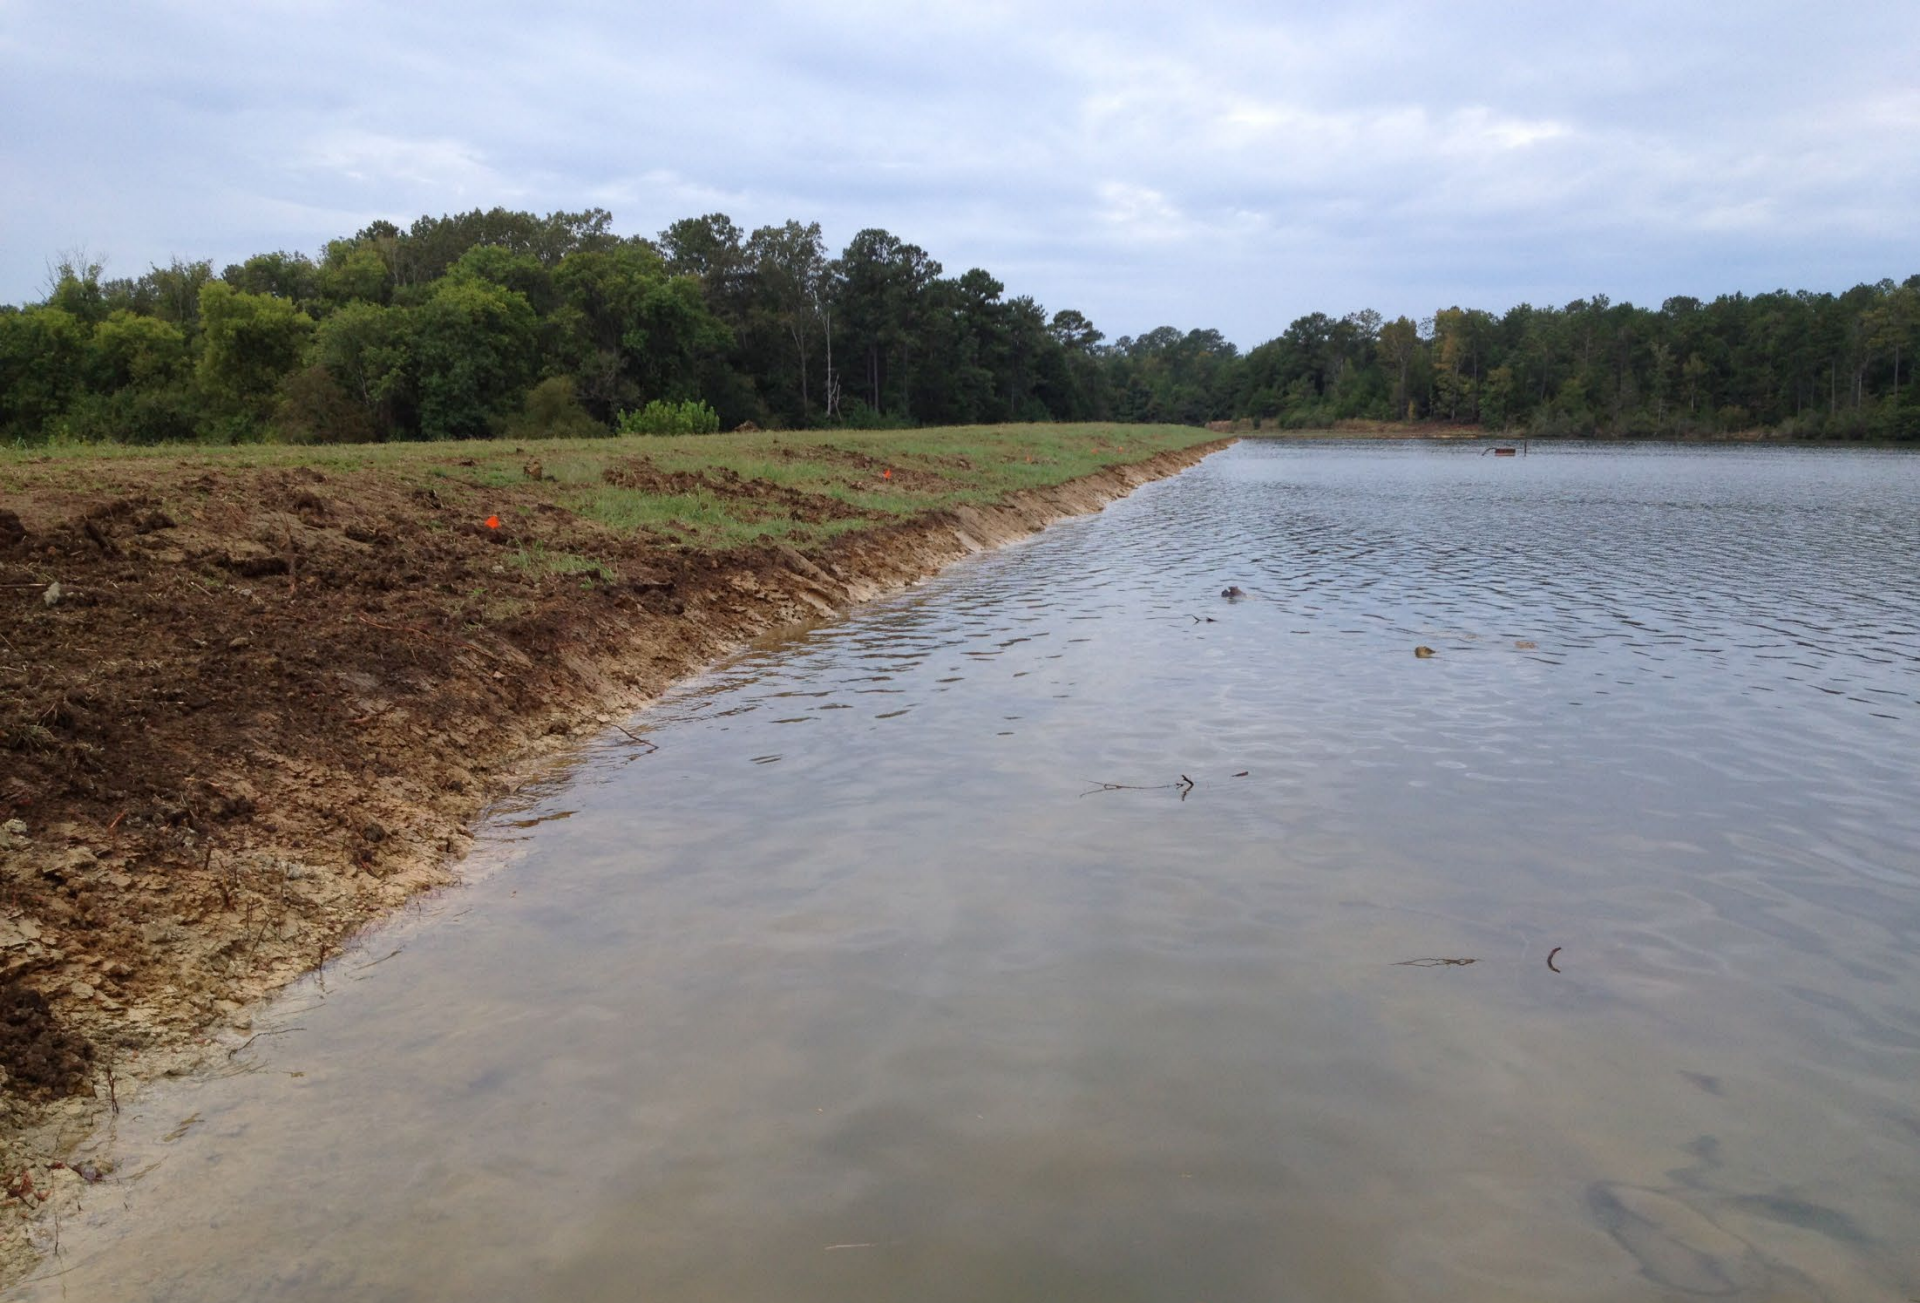
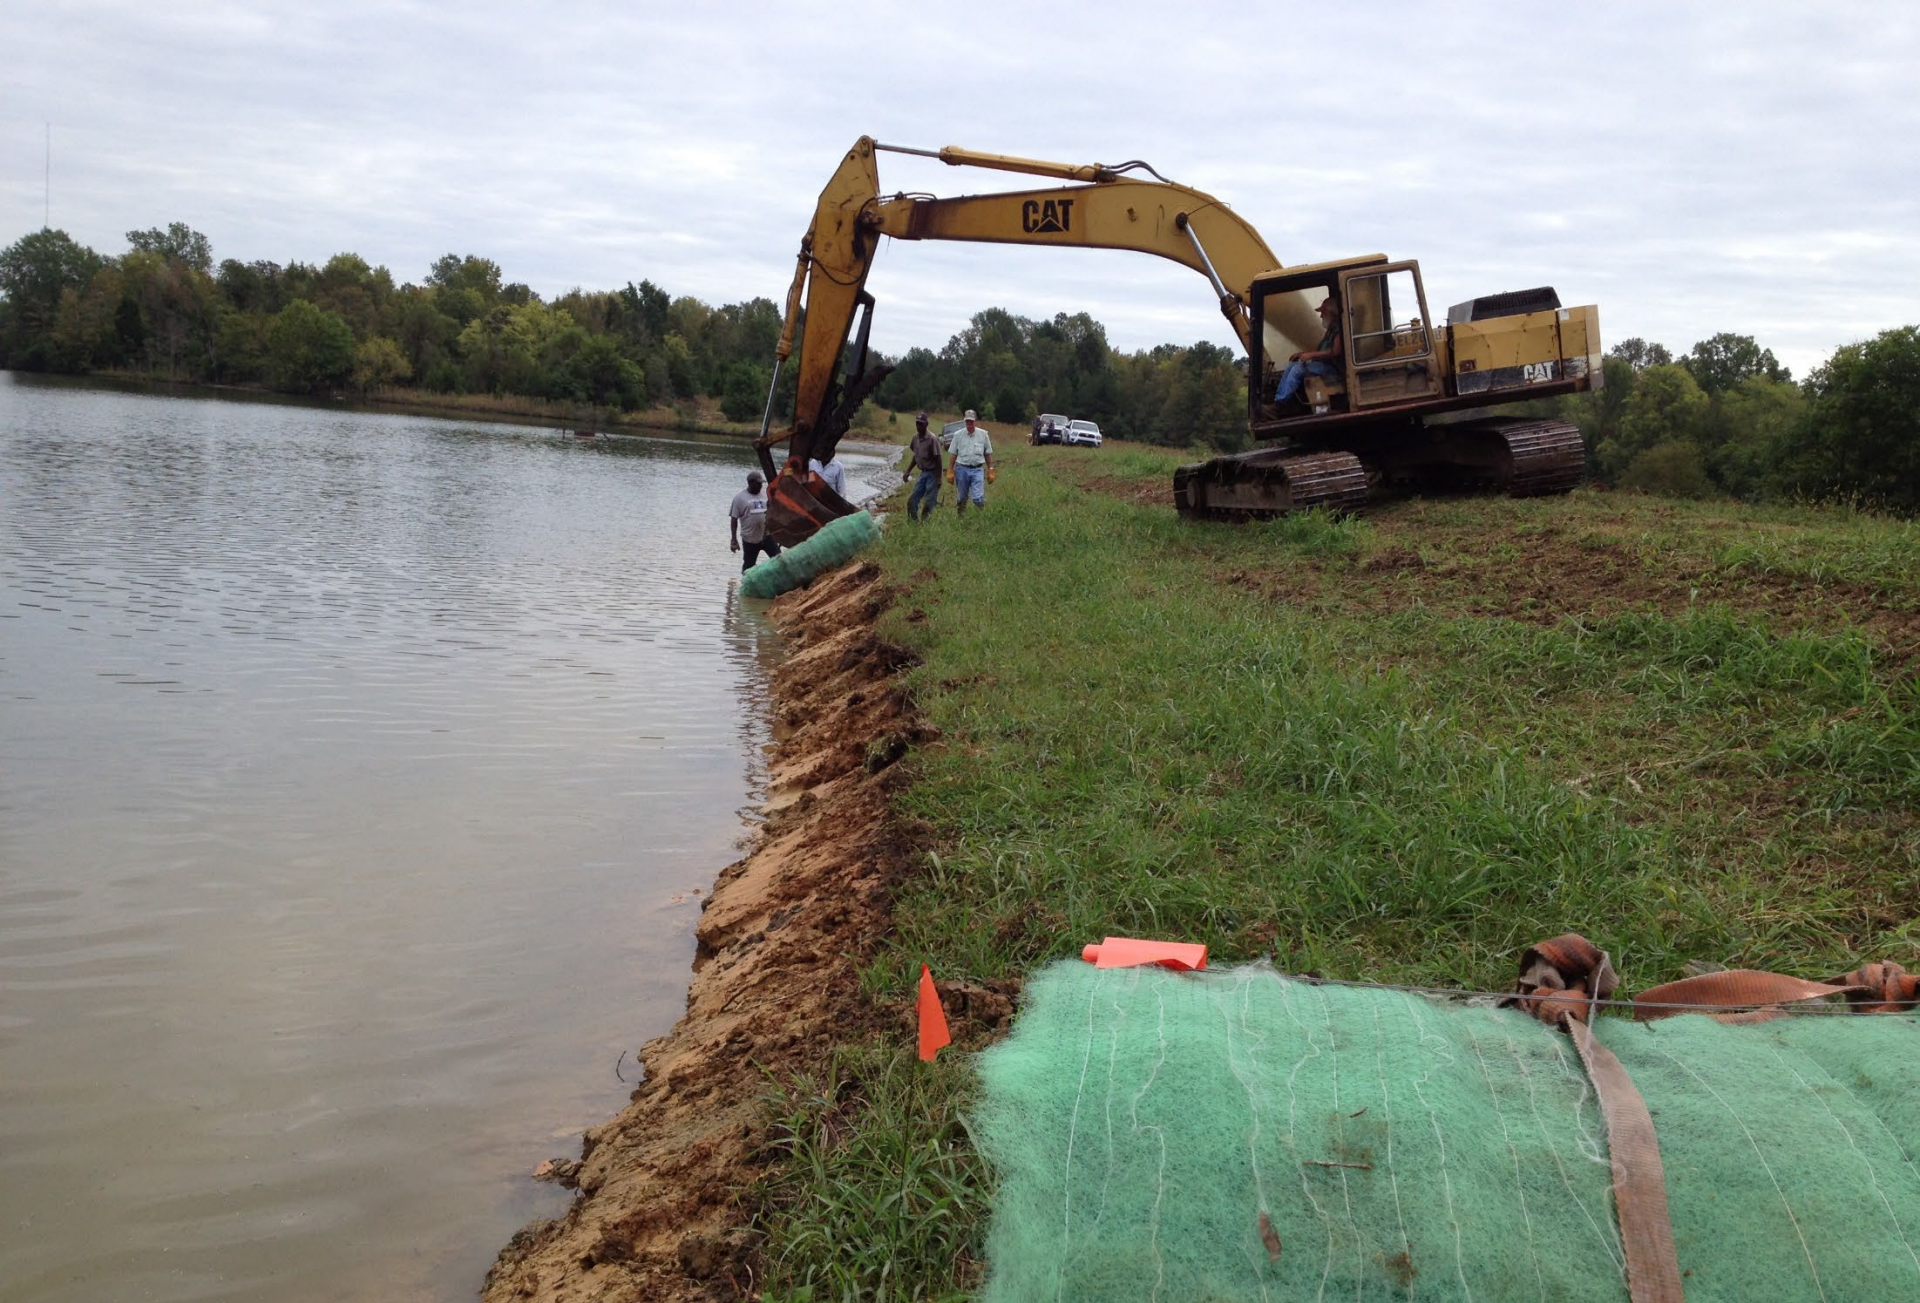
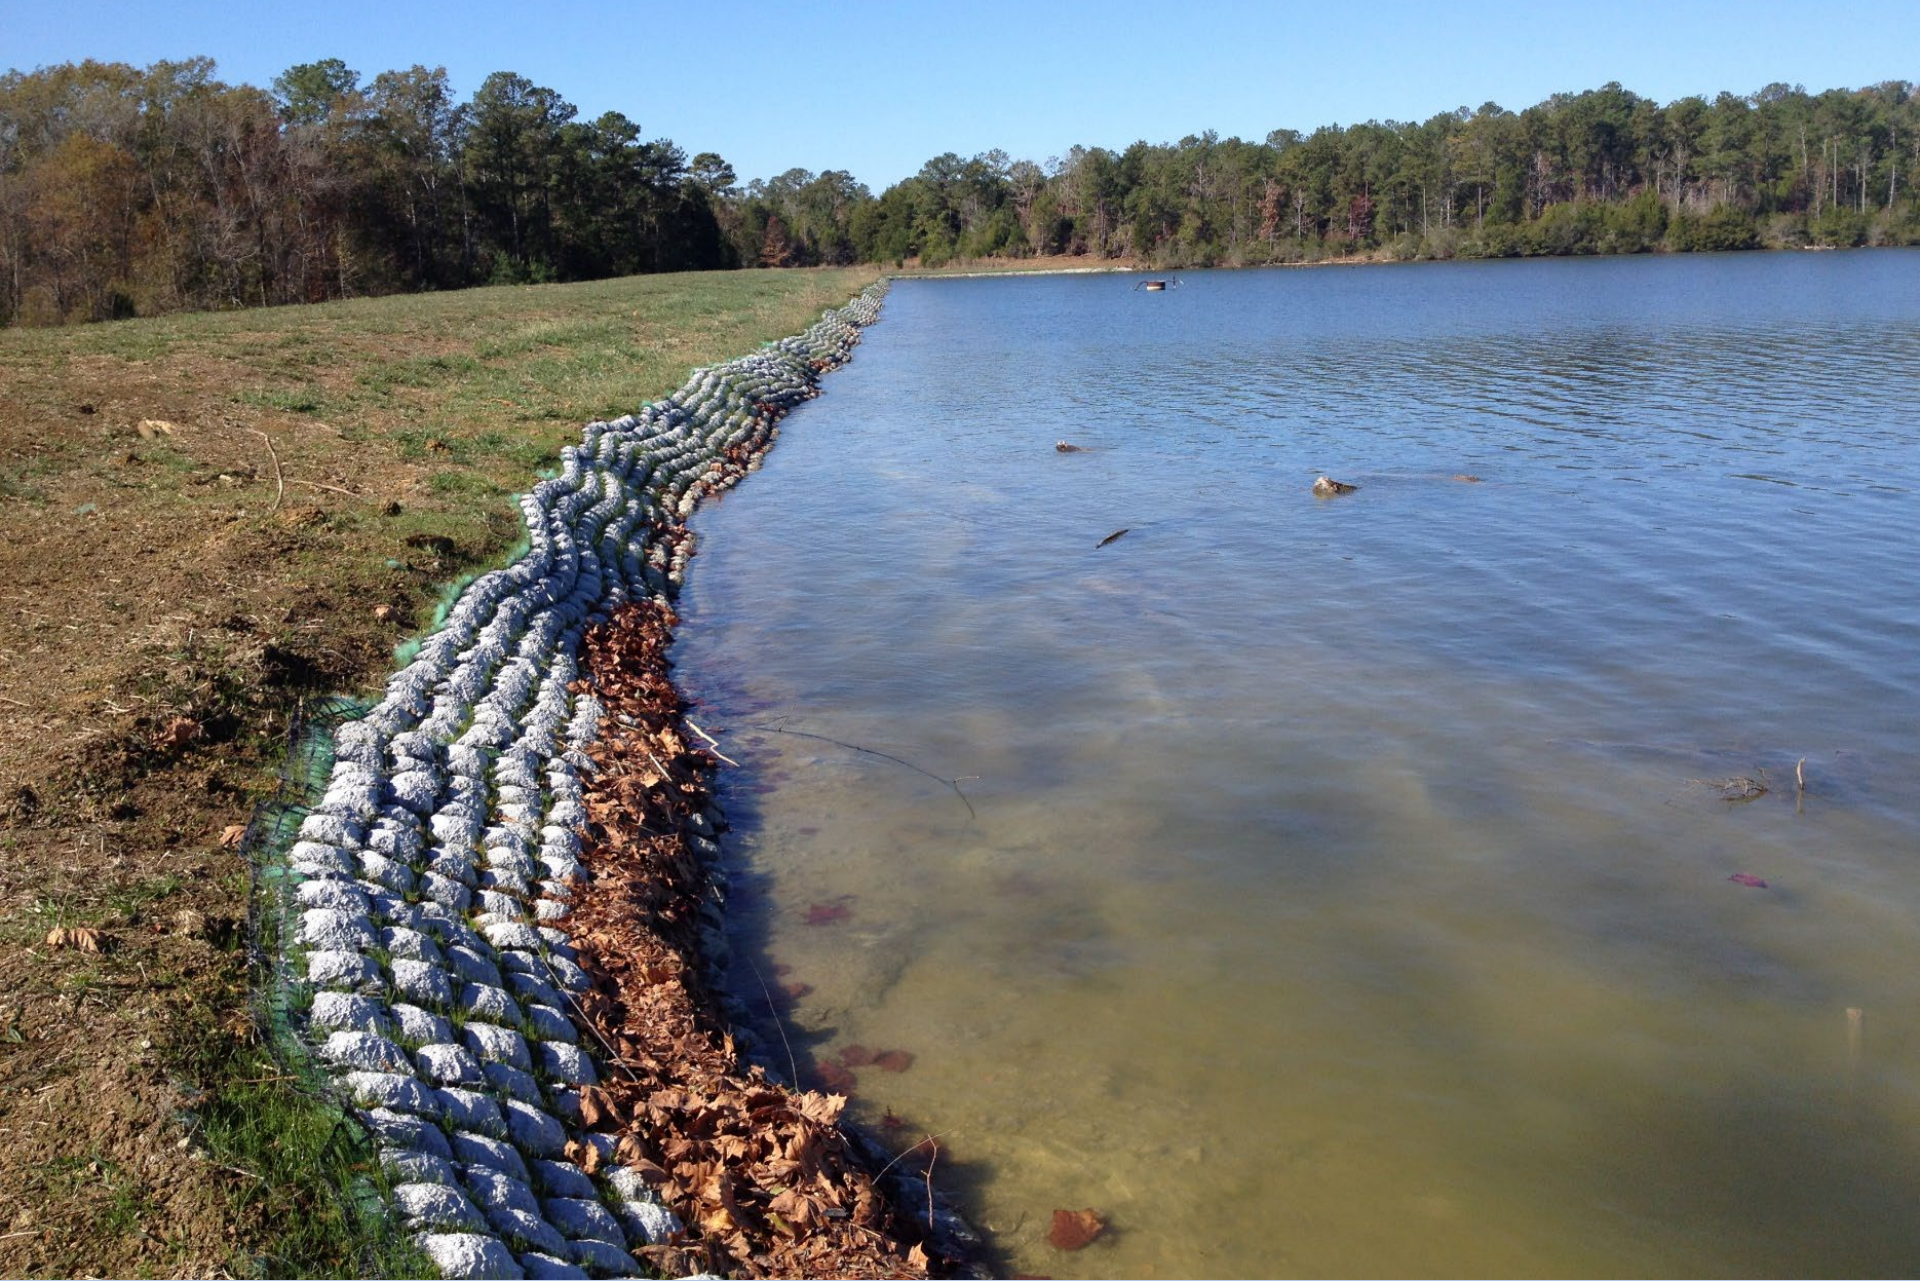
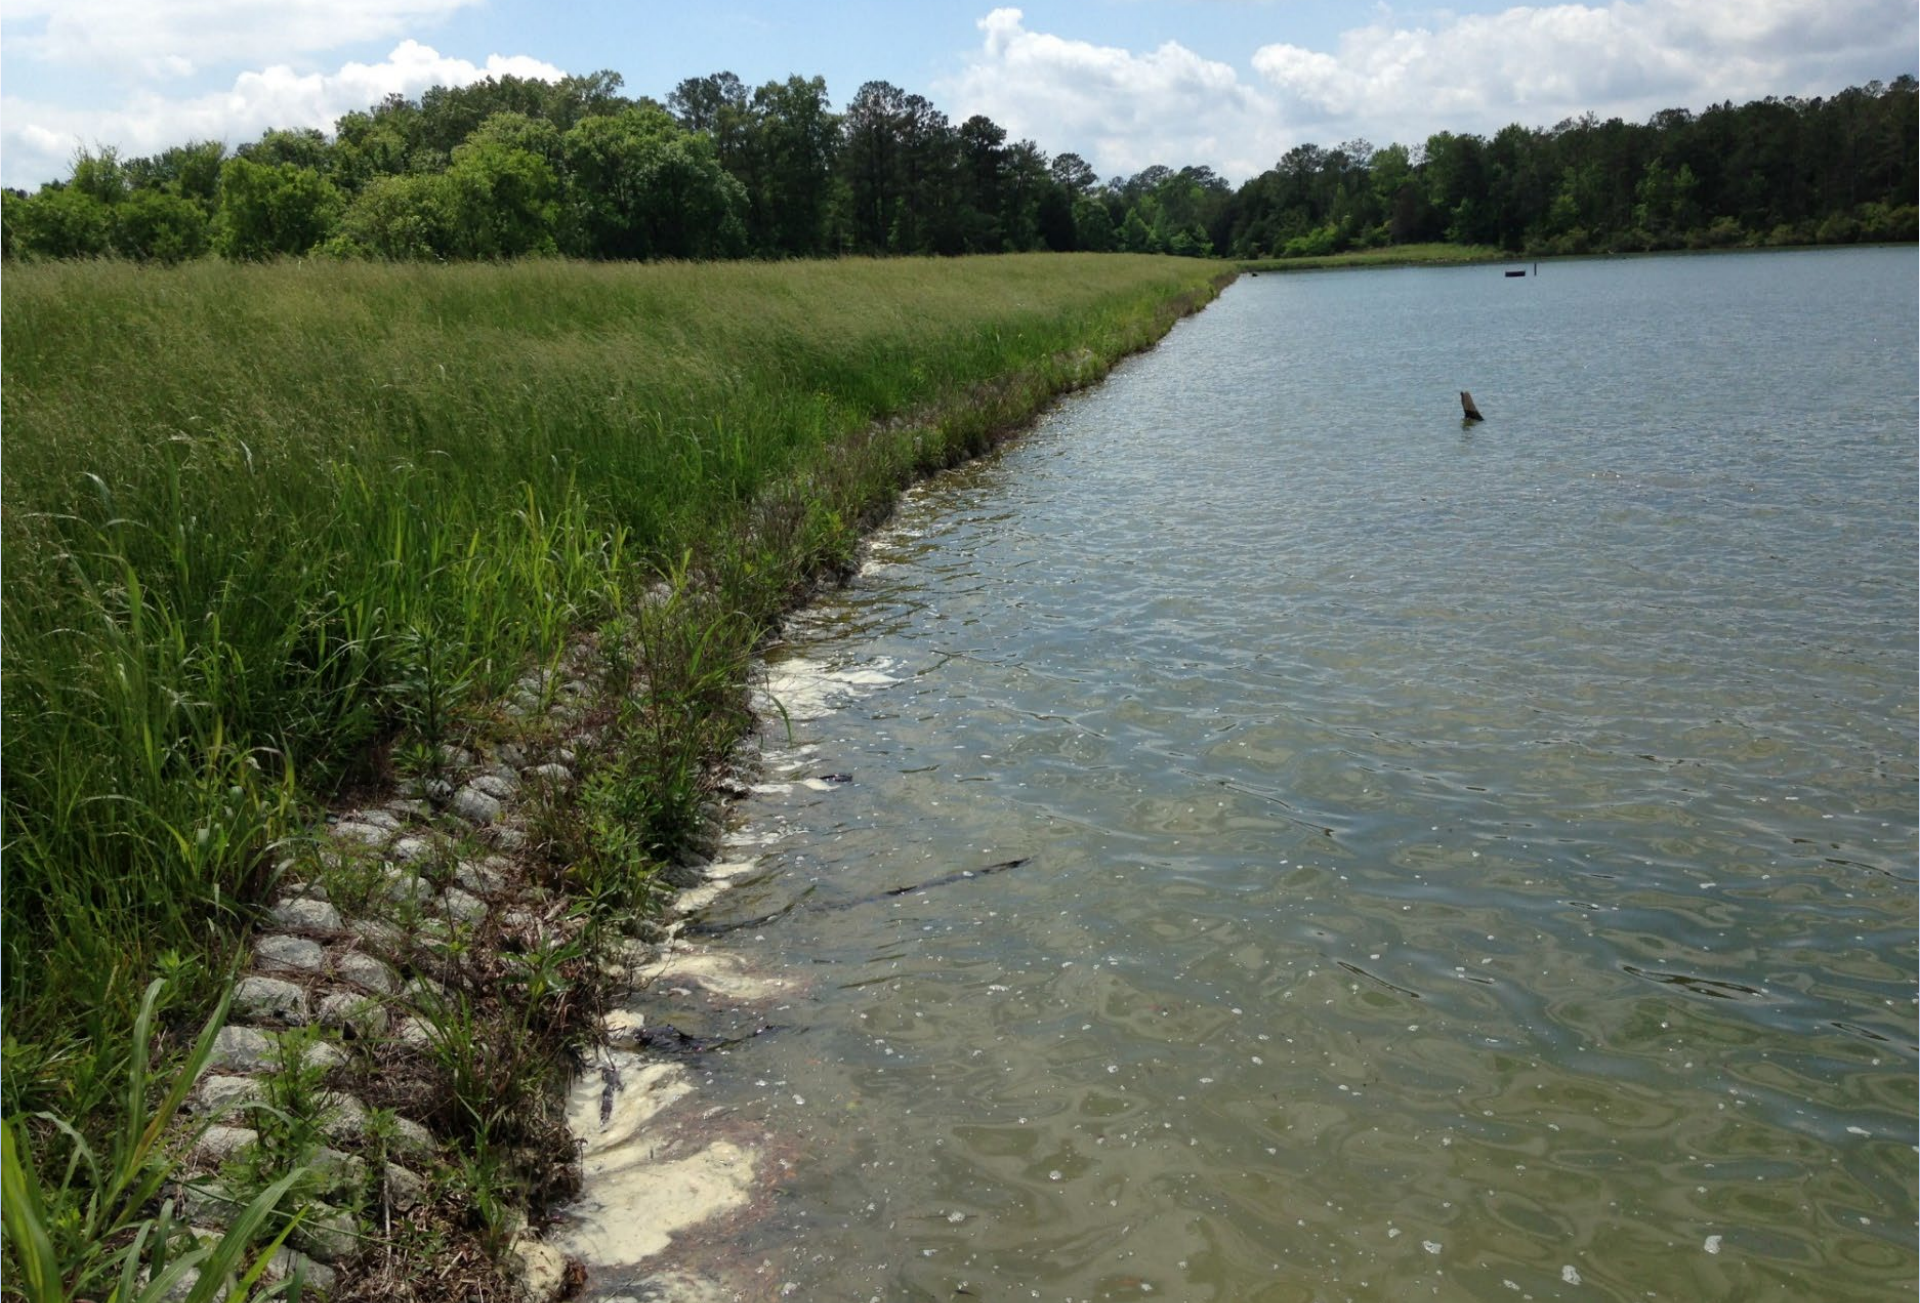
2013 - Lowndes County, AL

# WITHIN THE WATERLINE
