# Flexamat?

# Flexamat Standard

# Flexamat Plus

# Flexamat 10NW

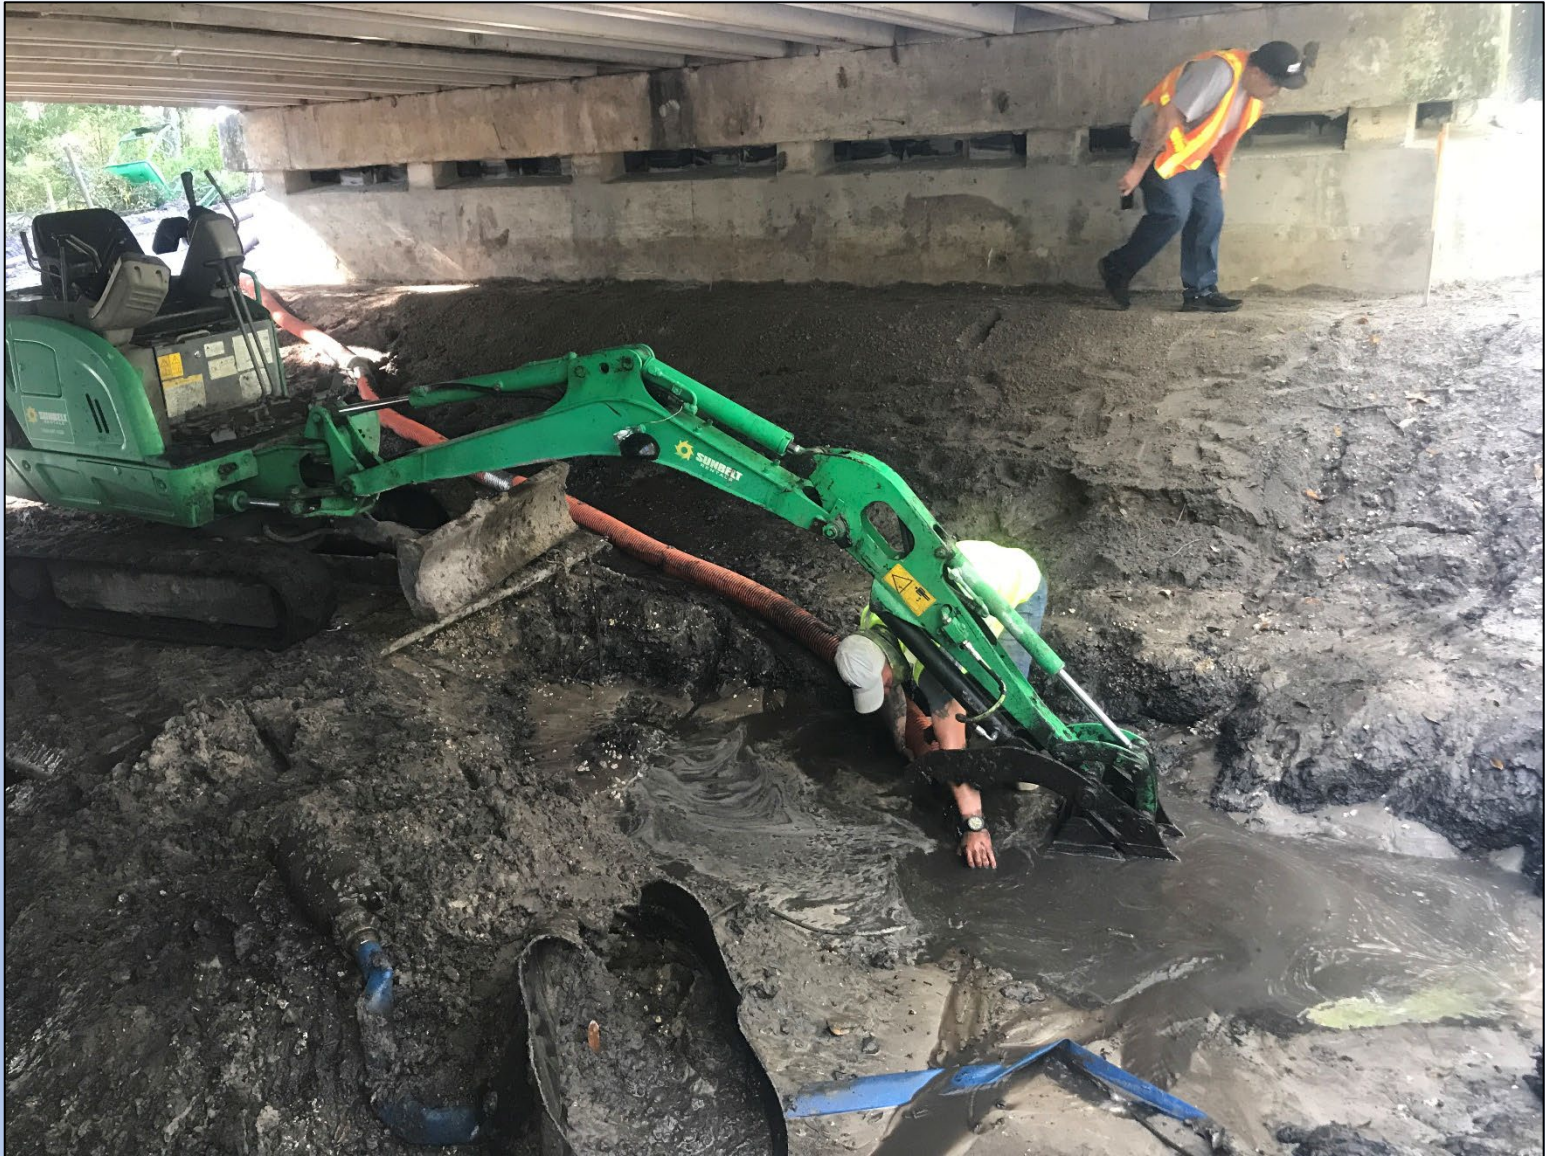
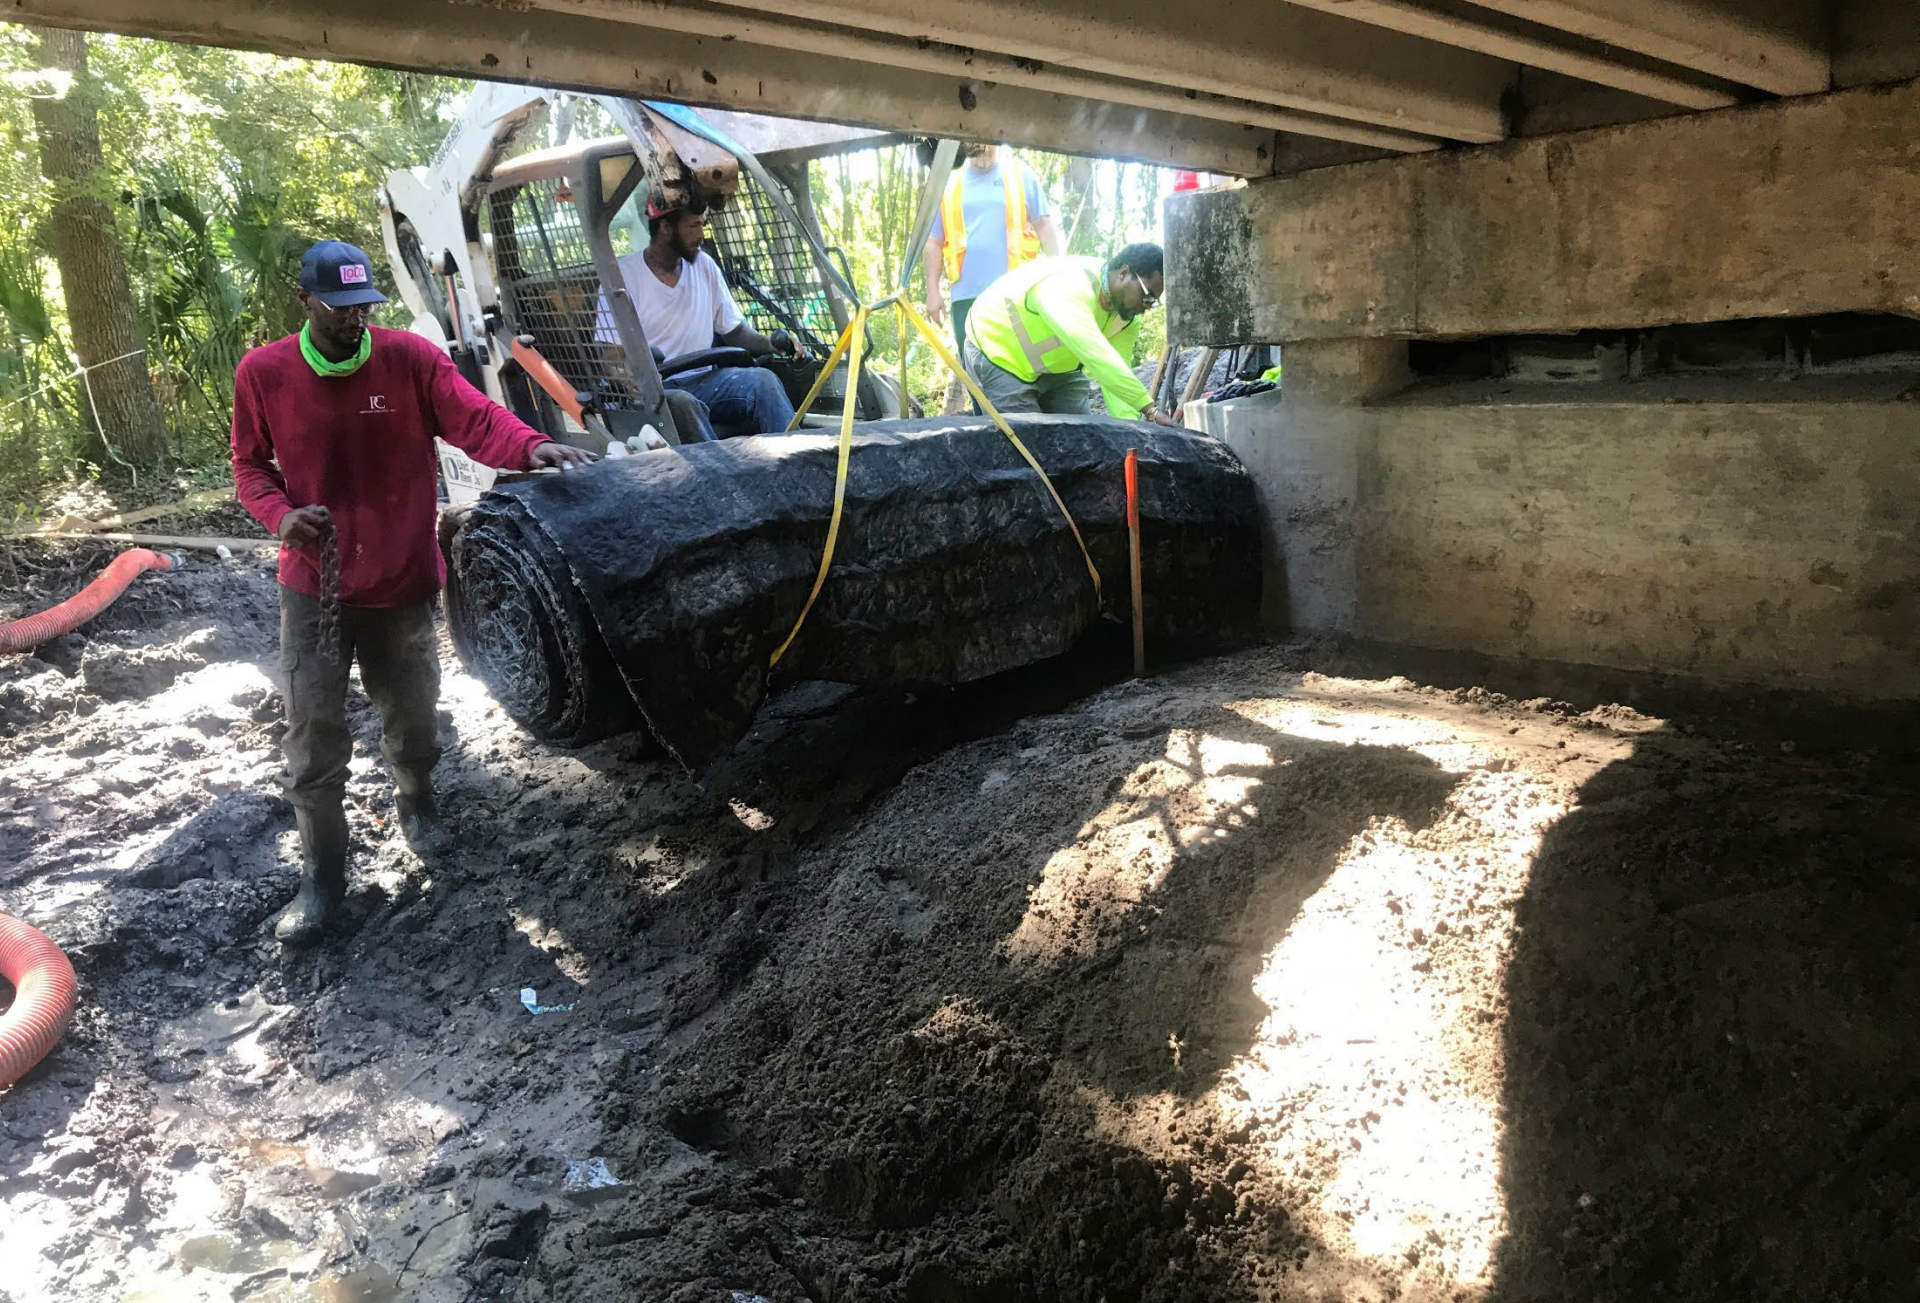
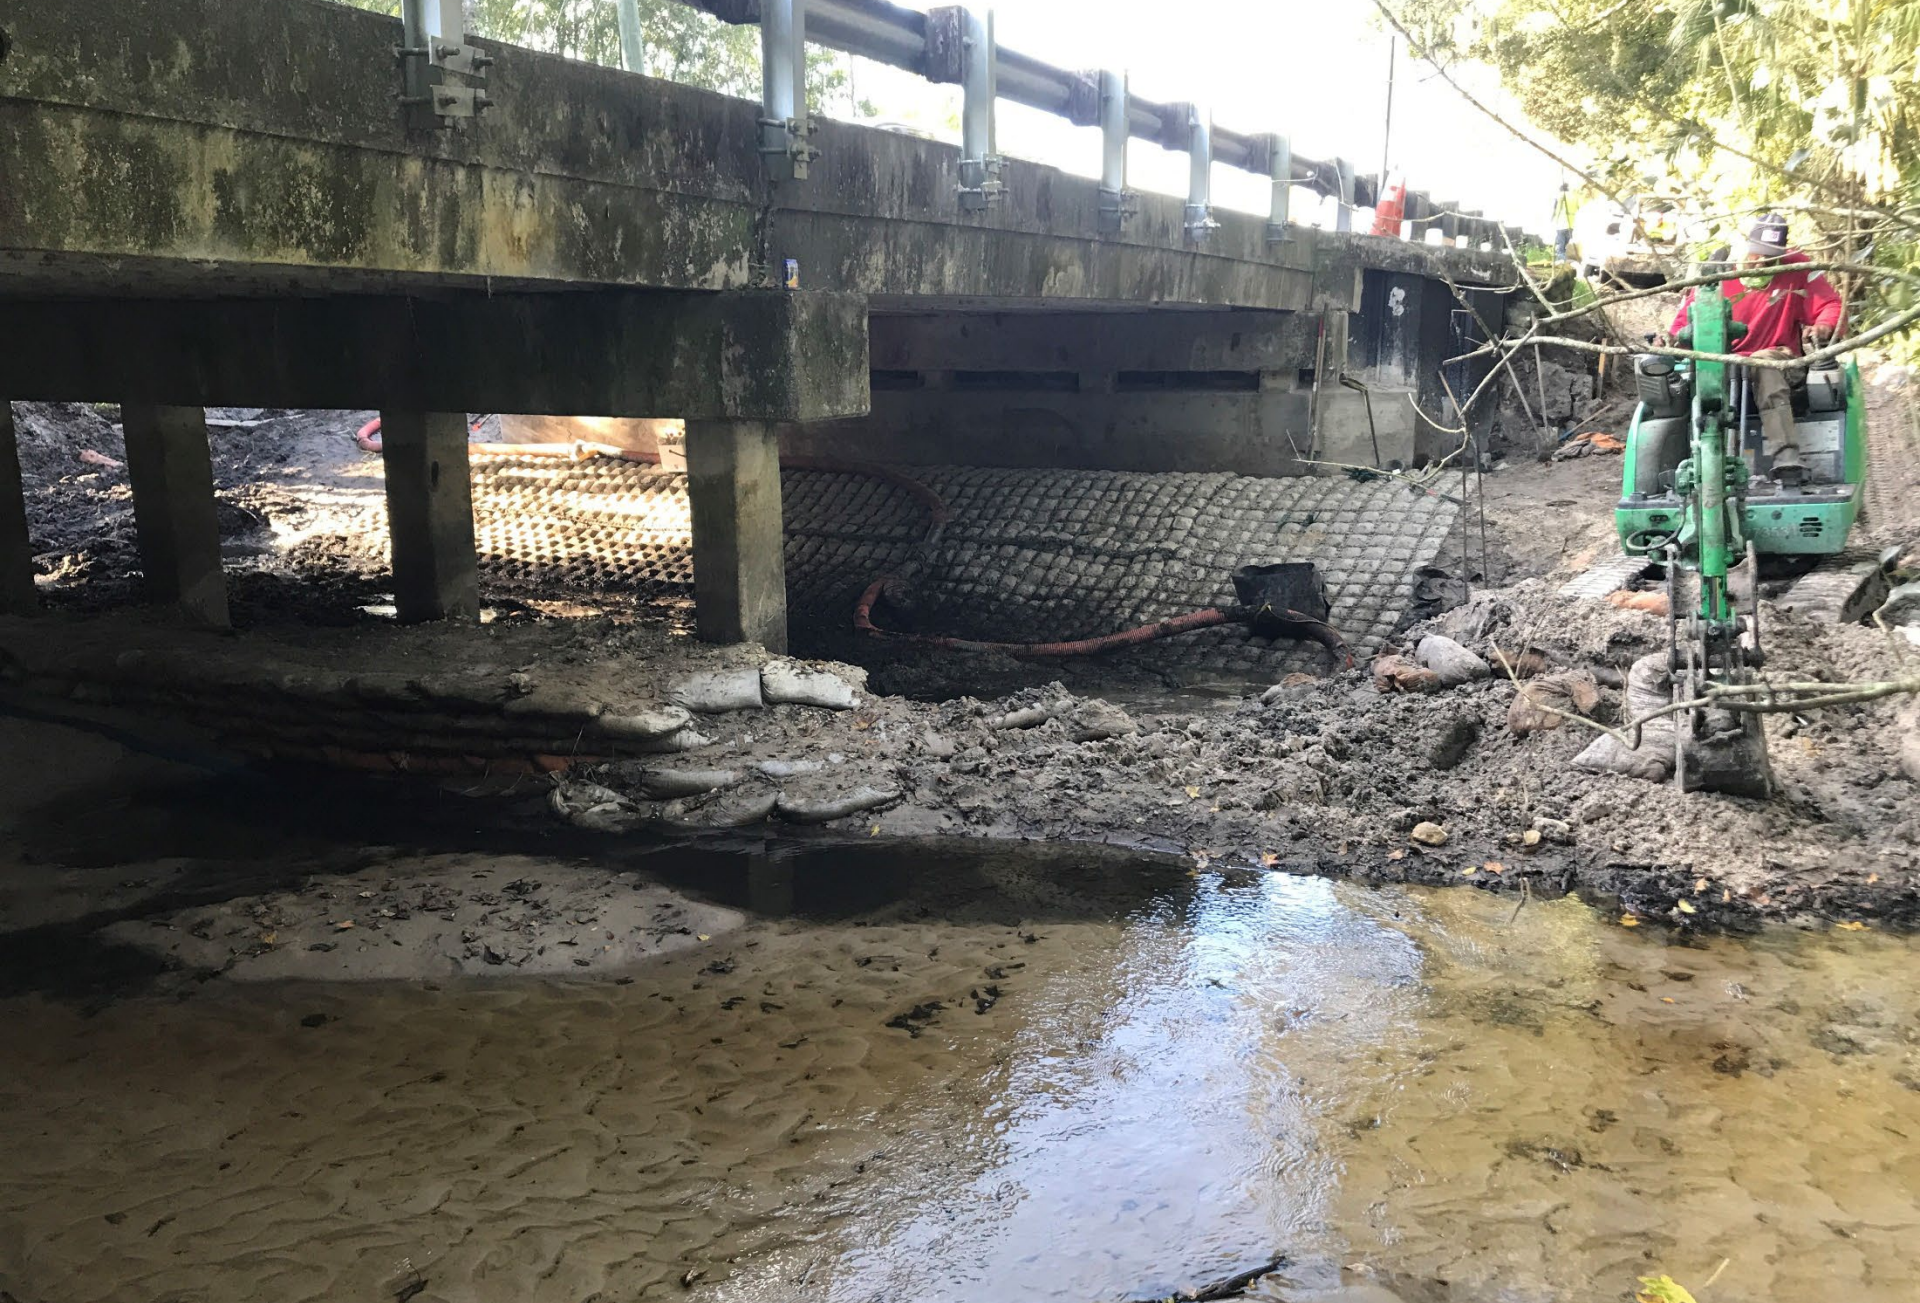
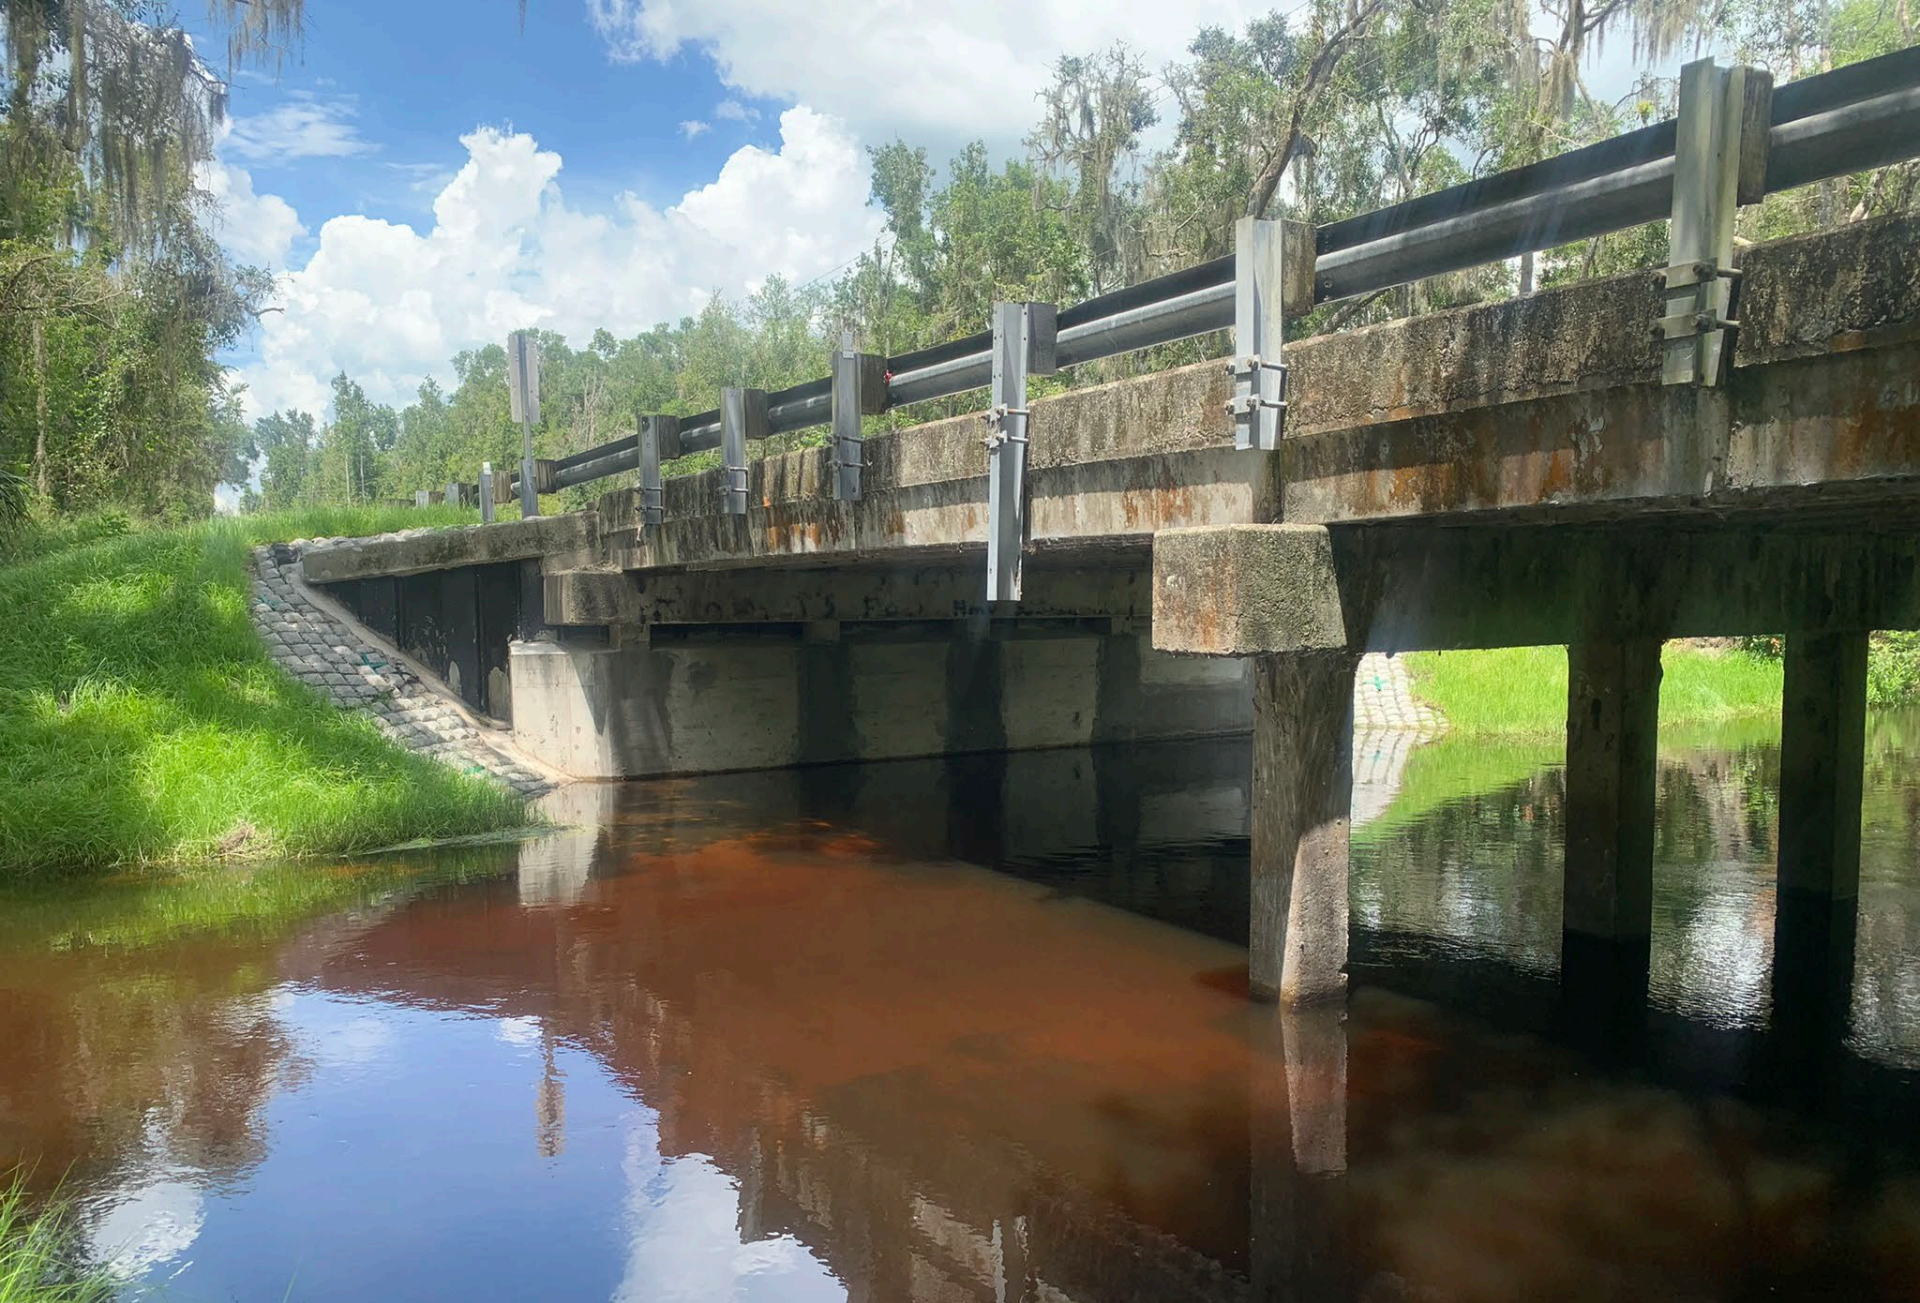
2023 – Lithia, Florida

# BELOW THE WATERLINE
